Manhole Inspection Summary

Manhole # S23II_038MH

Location Address: **2334 PENNSYLVANIA AVE** Cross Street: **CUMBERLAND ST**

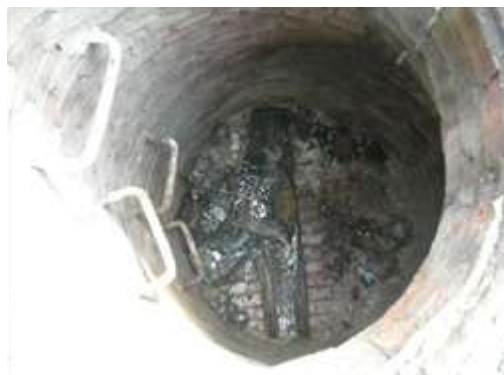
Top View

Steps Count: **5** Missing: **0** ☒ **Corroded**

Surcharge ☒ **Evidence Of Surcharge** Depth: **4** (ft.) ☐ Active Surcharge Present

Corroded steps. Evidence of surcharge - Bench debris. Channel debris.

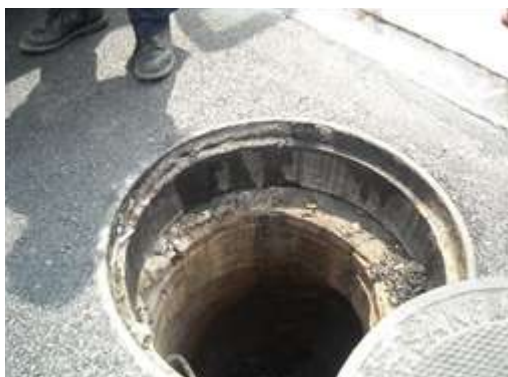
Defect

Frame Offset: **5** (in.) Condition: ☒ Sound ☐ Cracked ☐ Leaks

Chimney / Frame Adjustment ☒ Exists Material: **Brick** ☐ Parged Height: **3** (in.)
Condition: ☐ Sound ☐ Cracked ☐ Root Intrusion ☐ Loose Brick ☒ **Deteriorated**
Infiltration: ☐ None ☒ **Joint** ☐ Cracks ☐ Mortar ☐ Roots ☐ Wall

Barrel Material: **Brick** ☐ Parged
Shape: **Circular** Diameter: **48** (in.) Length: (in.)
Condition: ☒ Sound ☐ Cracked ☐ Root Intrusion ☐ Loose Brick ☐ Deteriorated
Infiltration: ☐ None ☐ Joint ☐ Cracks ☒ **Mortar** ☐ Roots ☒ **Wall**

Frame offset. Adjustment deterioration and infiltration. Barrel infiltration - other side.

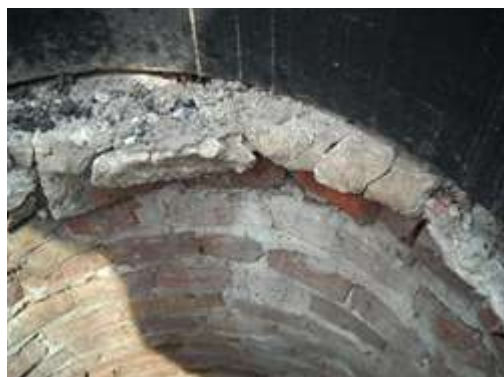
Defect

Frame offset. Adjustment deterioration and infiltration.

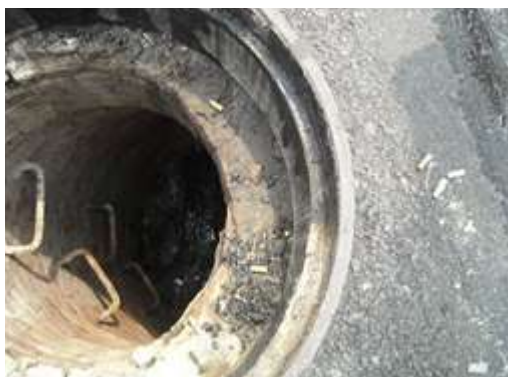
Defect

Frame offset. Adjustment deterioration and infiltration. Barrel infiltration.

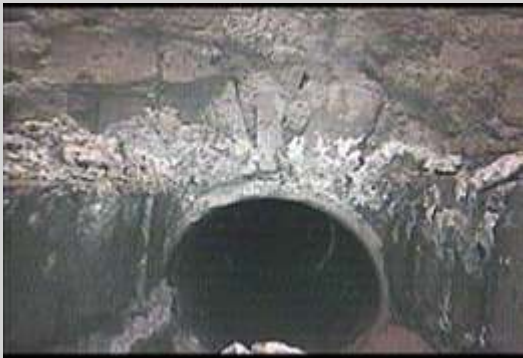
8 in. Circular Gravity Sewer Pipe Out @ 12 O'Clock

Deposits: ☐ None ☐ Mud ☒ Gravy ☐ Debris ☒ Grease

Silt Depth: **1** (in.) Deposits Extent: **Light**

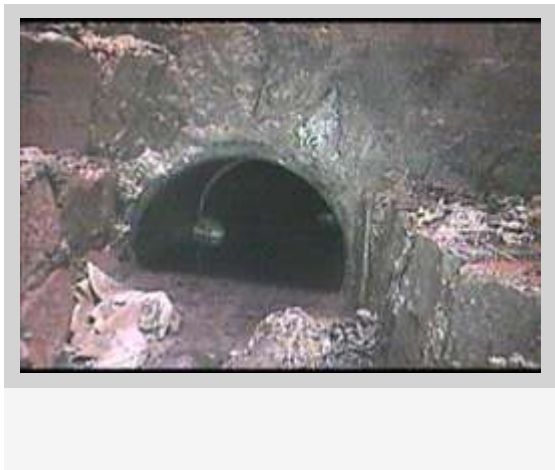
8 in. Circular Gravity Sewer
Pipe In @ 8 O'Clock

Deposits: ☐ None ☒ **Mud** ☒ **Sludge** ☒ **Debris** ☐ Grease

Silt Depth: **2** (in.) Deposits Extent: **Light**
